2017 Ferrari Club of America Major Award Winners 1969 365 GTB/4 Speciale s/n 12925, Luigi Chinetti Memorial Award for Outstanding Ferrari Road Car (foreground), 1960 250 GT Pinin Farina Coupe Series II s/n 1747 GT, National Vintage Preservation Award for Best Preserved Ferrari Pre-1980 (background).

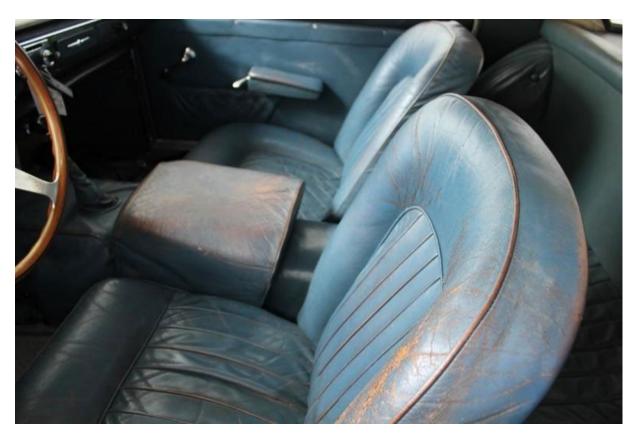
2. Worn seats with original dye. 250 Coupe. Image David Eichenbaum

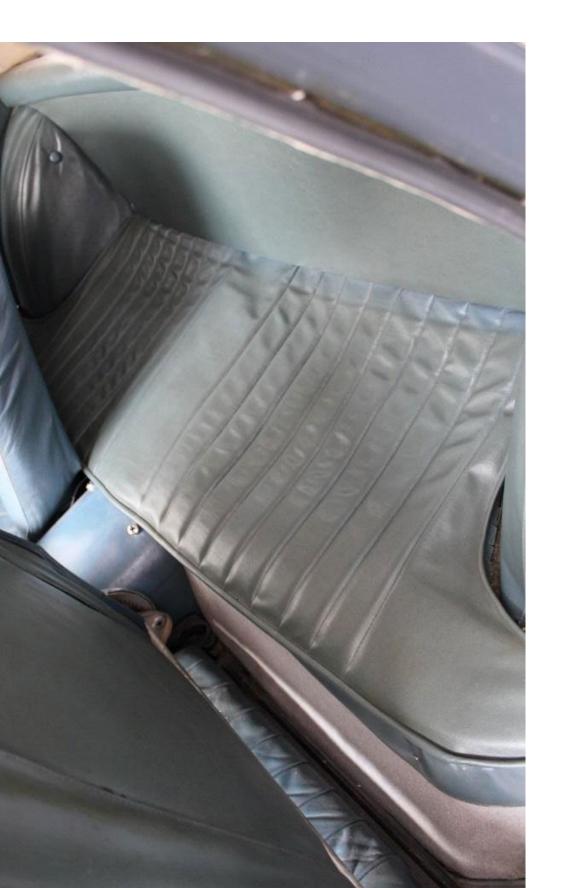
3. Worn original vinyl, pleats and piping. 250 Coupe. Image David Eichenbaum

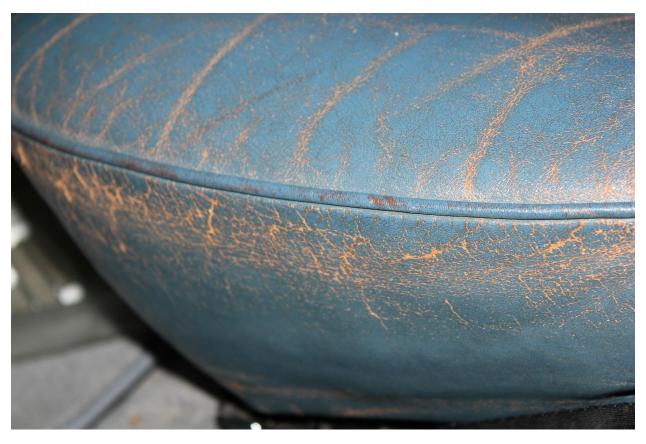
4. Detail of original leather dye and piping with original material underneath. 250 Coupe. Image David Eichenbaum

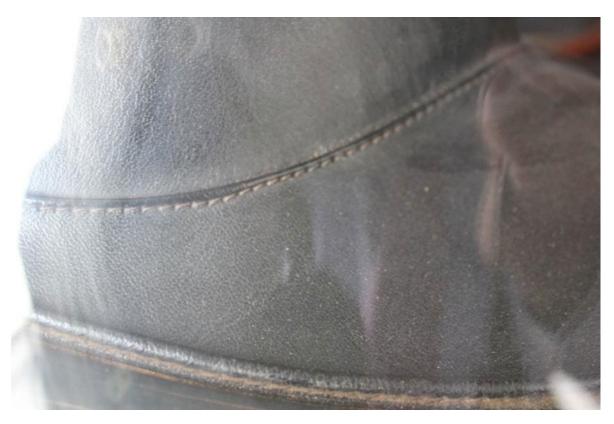
5. Original seats show grain, piping, stitching and workmanship. 250 Coupe. Image David Eichenbaum

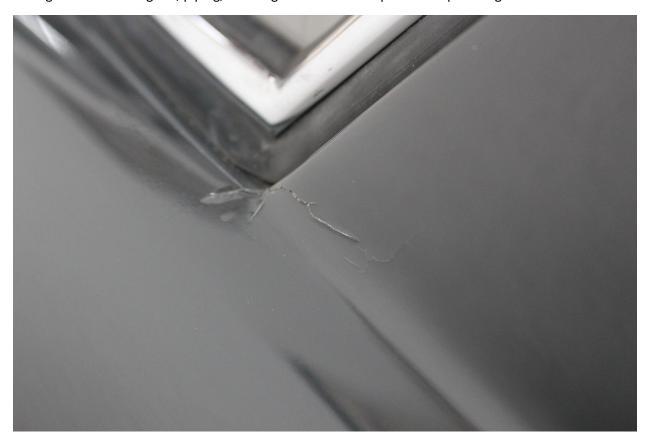
6. Typical cracking in older lacquer paint. 250 Coupe. David Eichenbaum

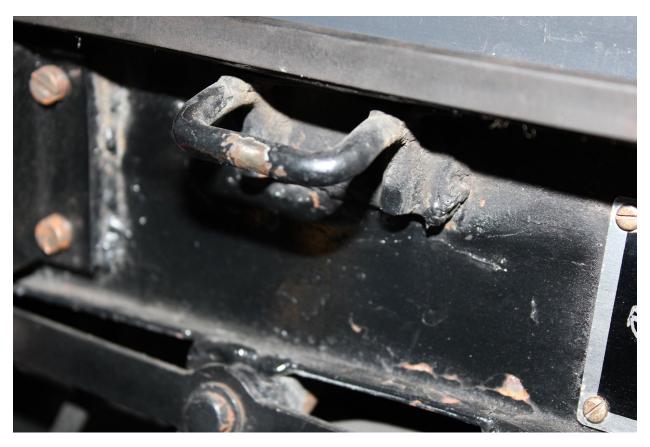
8. Hood latch originally painted over with welded latch and evidence of use. 250 Coupe. Image David Eichenbaum

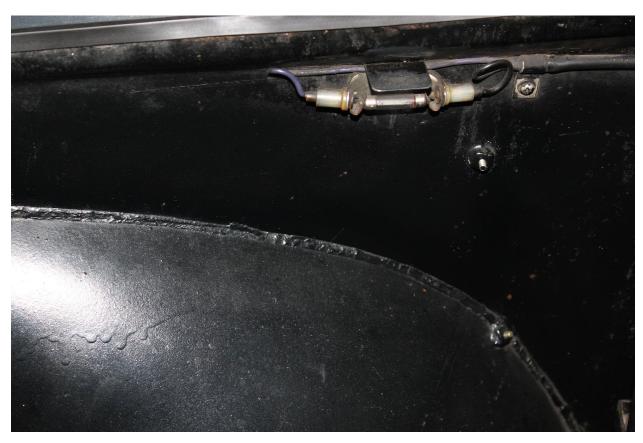
9. As built wiring and interior light with rough weld and run in inner fender paint. 250 Coupe. Image David Eichenbaum

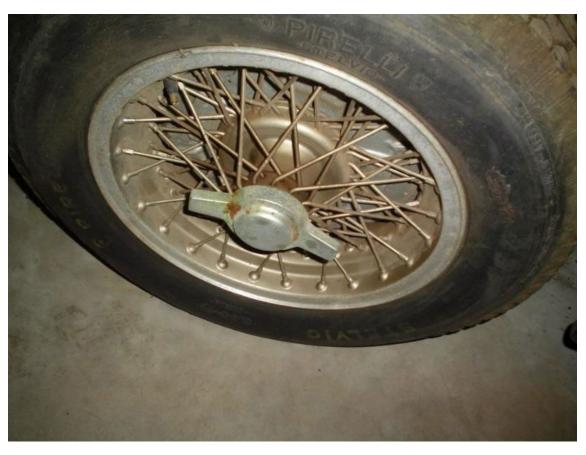
10. Early wheel still represents original configuration and finish. 250 Europa. Image David Carte

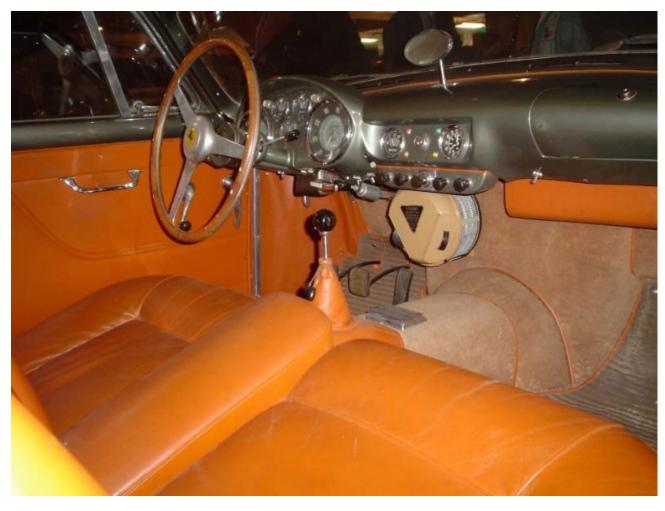
11. Original door skins, carpets, heel pads, piping, tassels, heater and dash. 250 Europa. Image David Carte

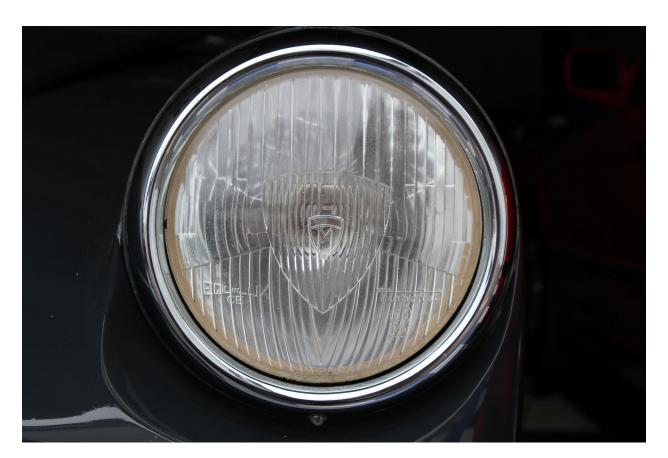
12. Marchal headlight with patina consistent with cars vintage. 250 Coupe. Image David Eichenbaum

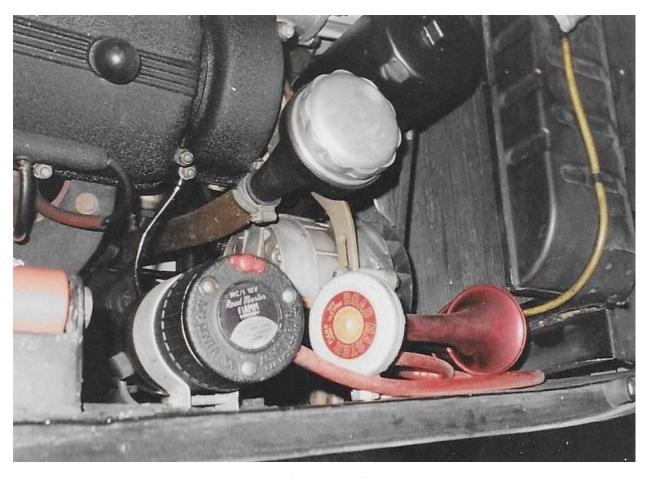
13. Typical unrestored engine details – except for painted filter. 250 GT Lusso. Image David Carte

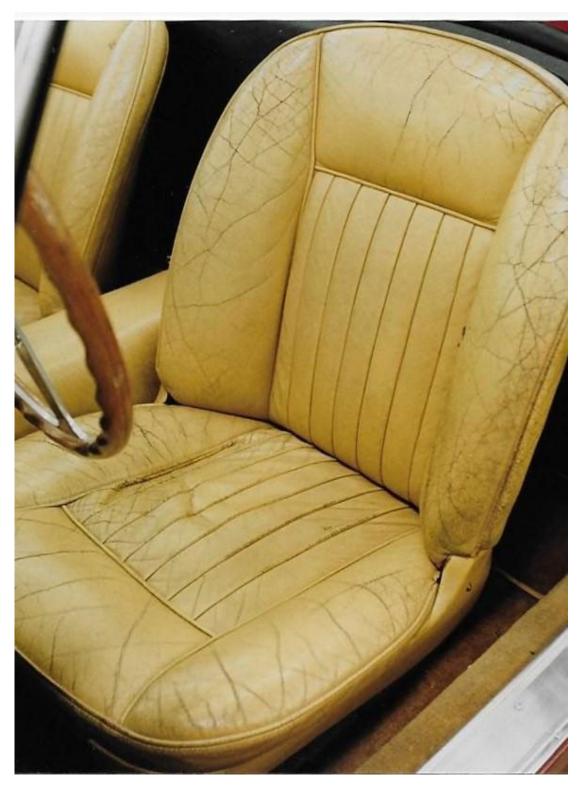
${\bf 14.\ Serviceable\ seat\ with\ minor\ tear.\ \ 250\ Cabriolet.\ Image\ David\ Carte}$

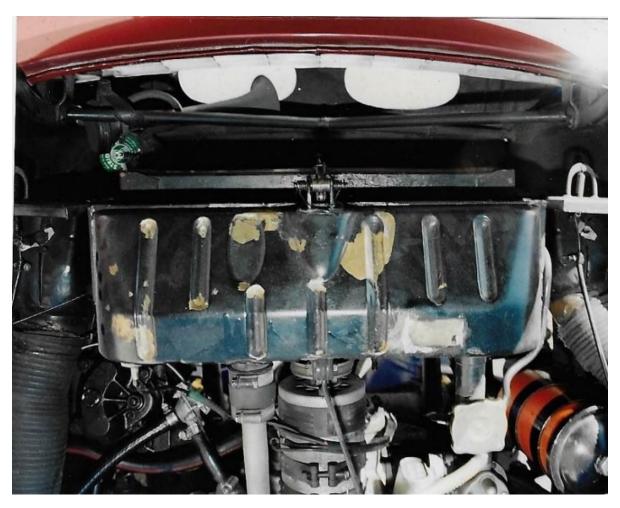
15. Weathered radiator functioning as original. 250 Cabriolet. Image David Carte

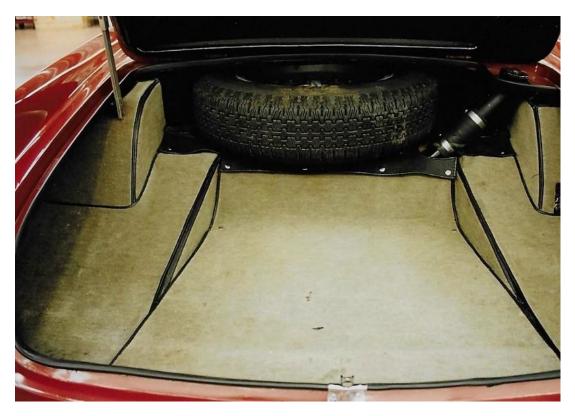
16. Original trunk and carpeting. Modern clamps and tire. Missing wiring block cover. 250 Cabriolet. Image David Carte

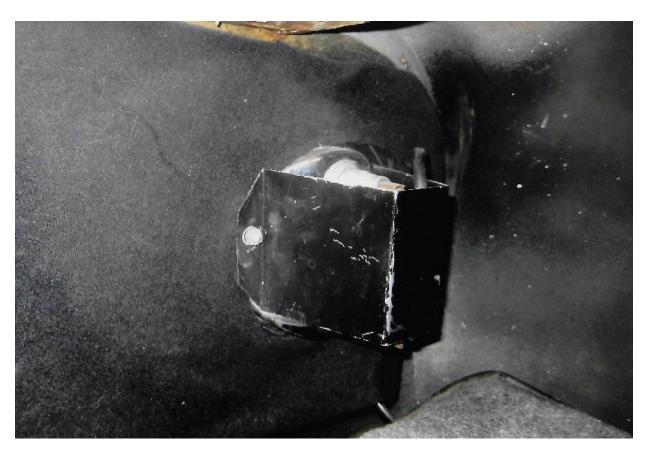
18. Inside trunk worn from use but serviceable. 250 Lusso. Image David Carte

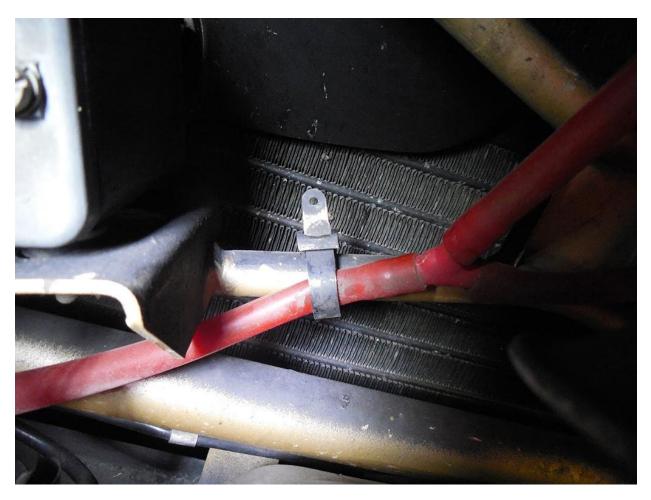
19. Black overspray on body-colored frame expected as inner fenders were likely sprayed from rear before radiator and engine were installed. 330 GTC. Image Tom Yang

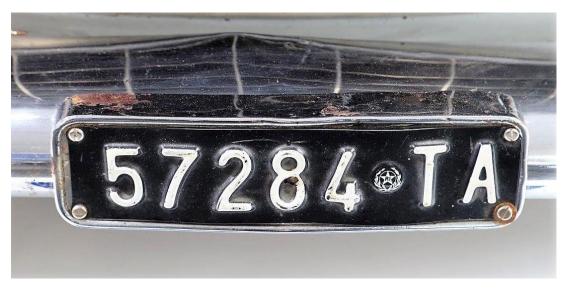
20. Front license plate frame – rough but original. 250 Europa. Image David Carte

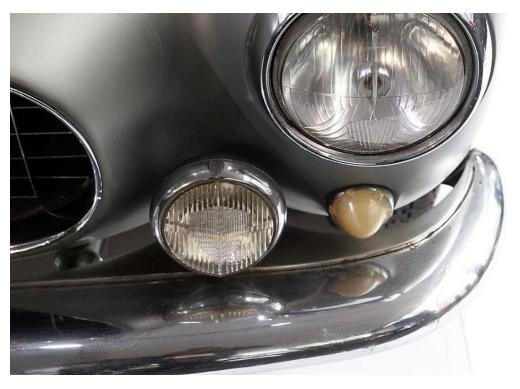
21. Dull chrome and slight blemishes on bumper. 250 Europa. Image David Carte

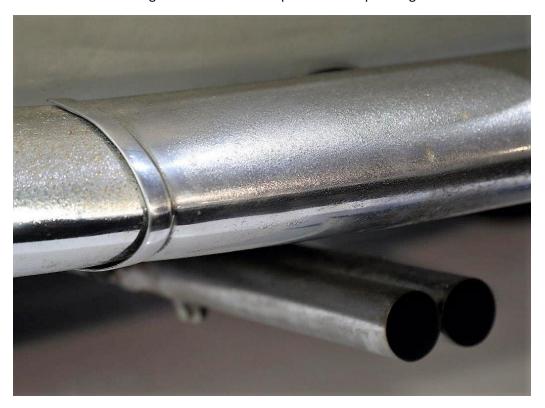
22. Weathering chrome still intact. 250 Europa. Image David Carte

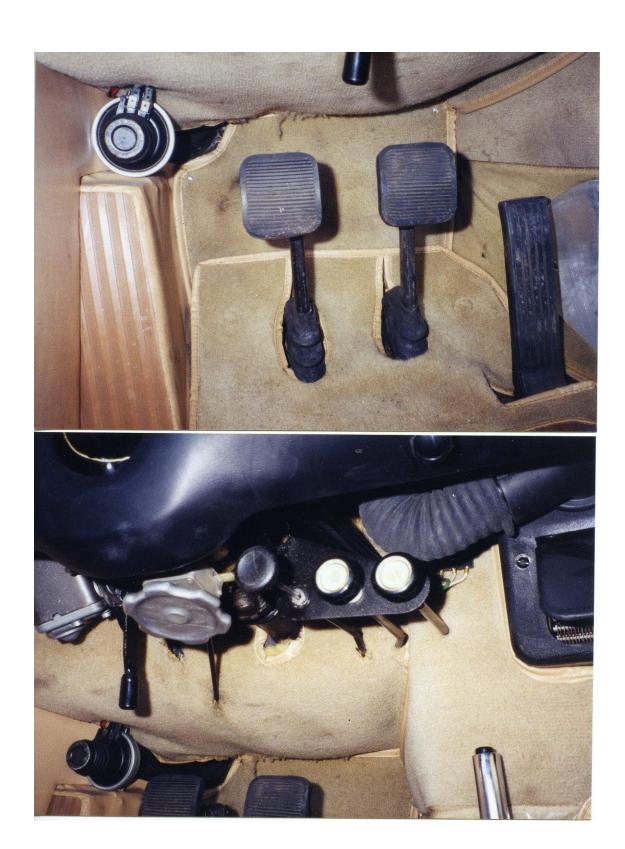
23. Rough fit, uneven stitching and untrimmed cut-outs reflect typical Scaglietti practice. 250 Lusso. Image David Carte

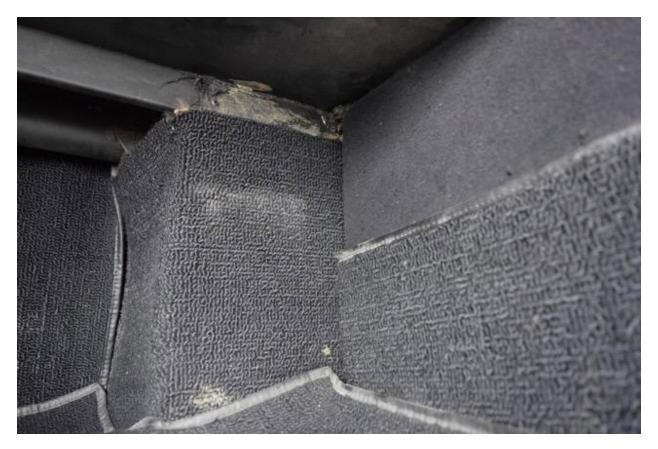
24. Trunk carpet, untrimmed as built with glue overlap on frame. 246 Dino. Image Marco Hartner.

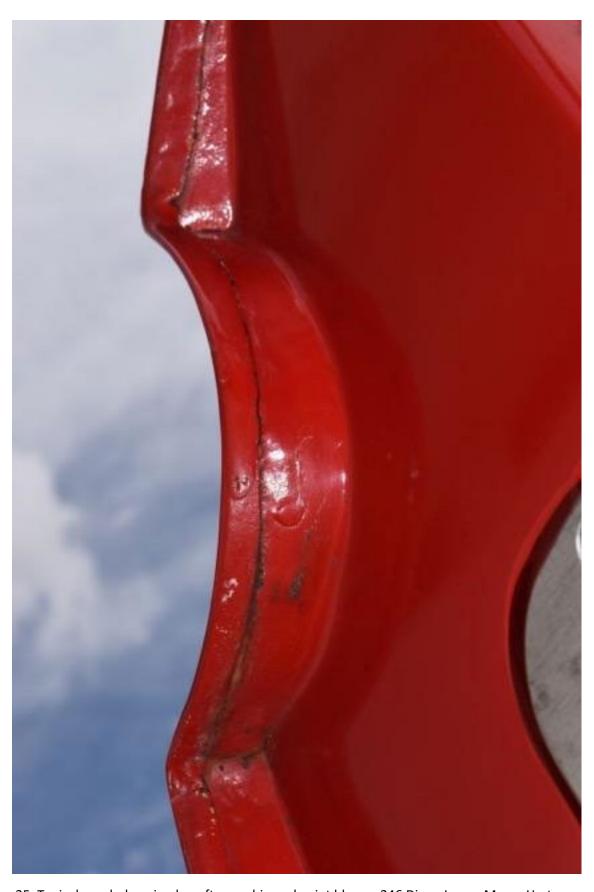
25. Typical rough door-jamb craftsmanship and paint blems. 246 Dino. Image Marco Hartner

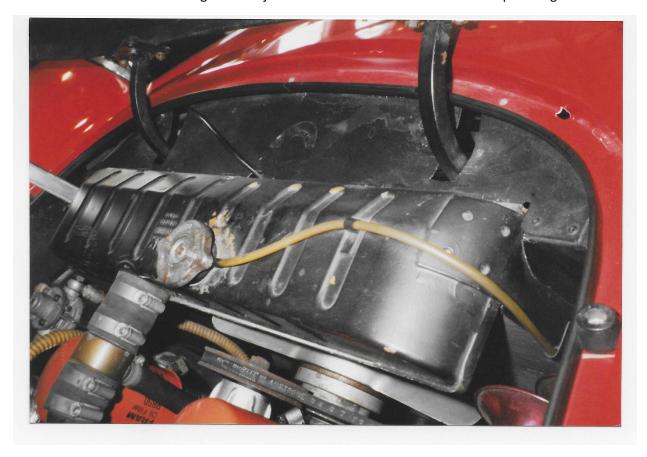
27. Weathered original details but belt probably replaced (acceptable). 250 Lusso. Image David Carte

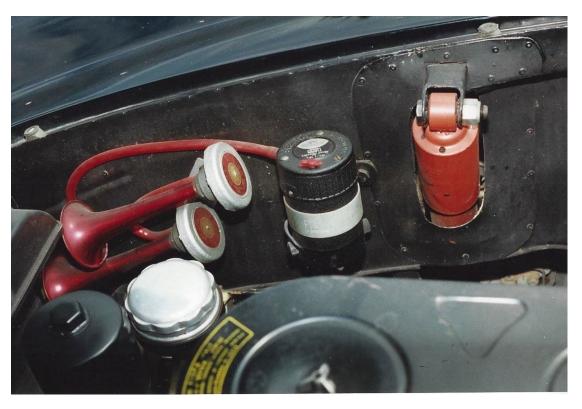
30. Typical original Lusso engine compartment except repainted oil filter. Note rivets, logos, horns. 250 Lusso. Image Greg Jones

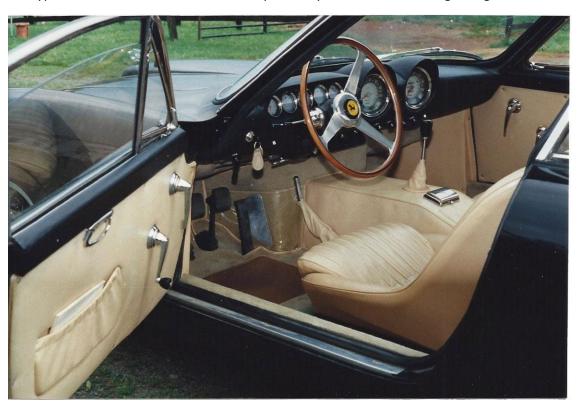
35. Original interior, puckered door pocket and console and plastic scuff guard. 250 Lusso. Image Greg Jones

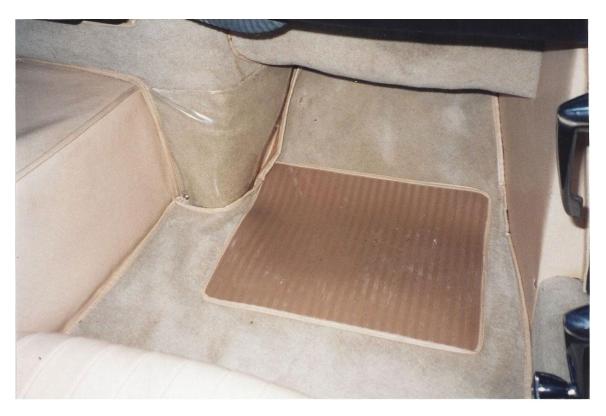
36. Plastic scuff guard, unevenly fitting vinyl bound mat. 250 Lusso. Images Greg Jones

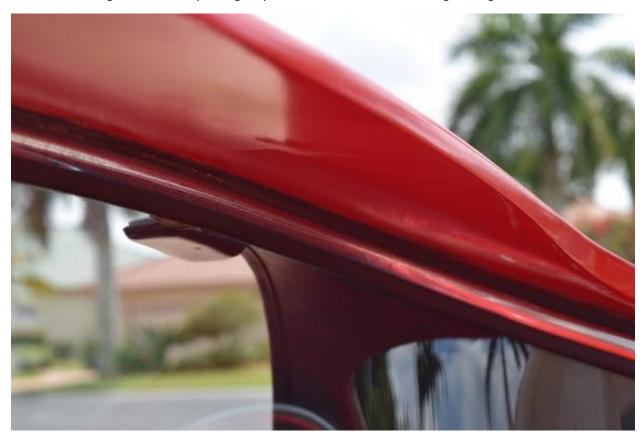
37. Typical factory paint blemish on door jam as delivered. 246 Dino. Image Marco Hartner

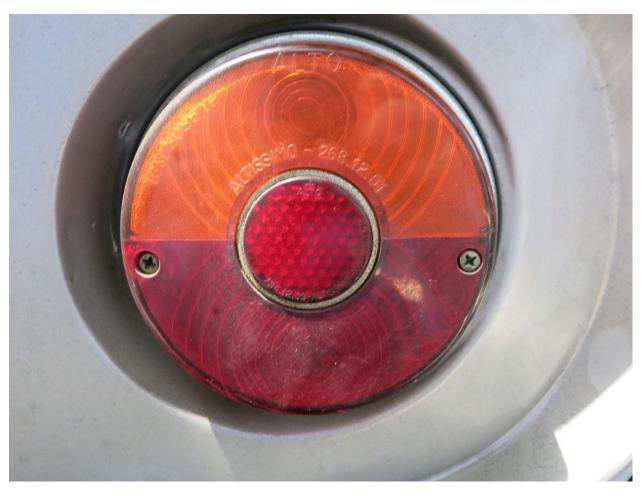
39. Aged tail light lens and screws with appropriate original patina. 275 GTB Alloy. Image Donovan Leyden

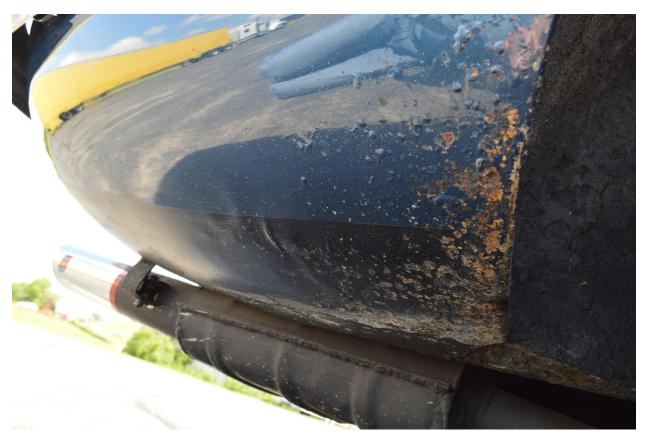
43. Original Daytona Speciale resonator with limited repair (welded cap). Owner resisted temptation to repaint despite some surface rust. Daytona Speciale. Image Dustin Wetmore

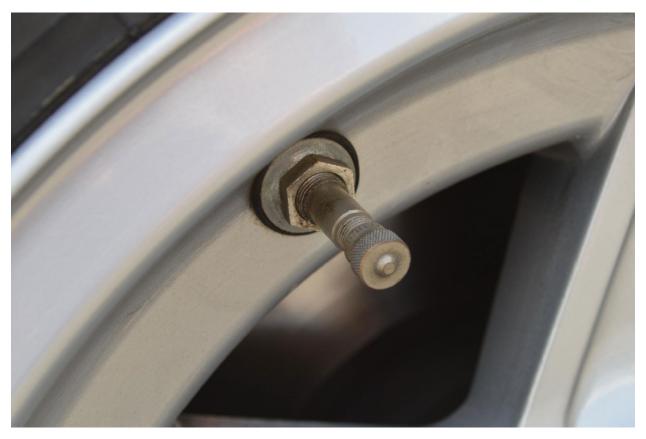
44. Serviceable Michelin XWX tube sleeve. Daytona Speciale. Image Dustin Wetmore

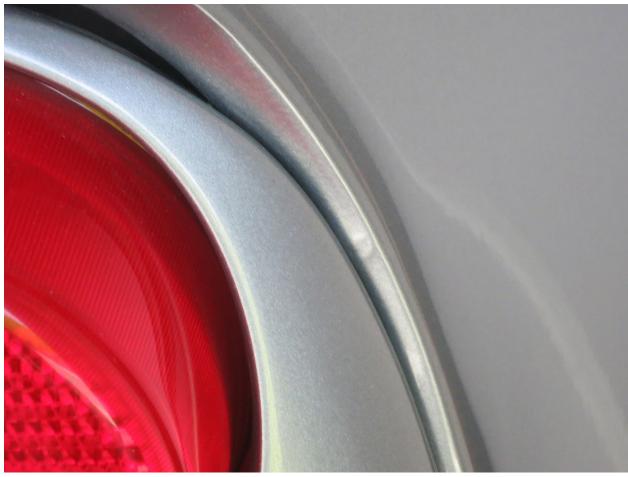
48. Typical factory paint blemish as Donovan Leyden	delivered in unlikely to not	ice taillight area.(Original 355.	Image

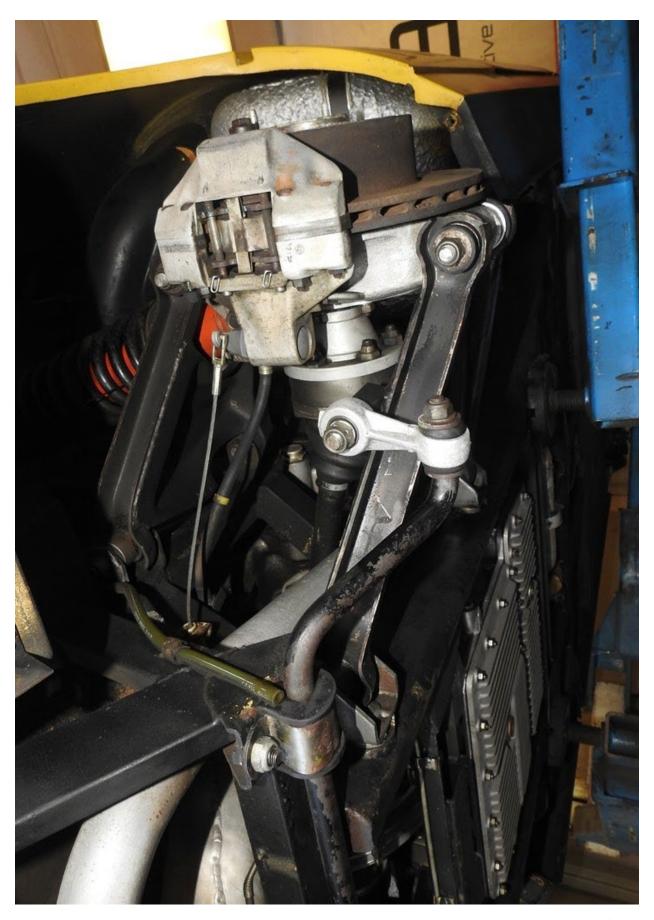
49. Original suspension and brakes with patina and cleaned with cryo. 308. Image Senega Archive/ERS
